Thermal Inspection of a Composite Fuselage Section using a Fixed Eigenvector Principal Component Analysis Method

ABSTRACT

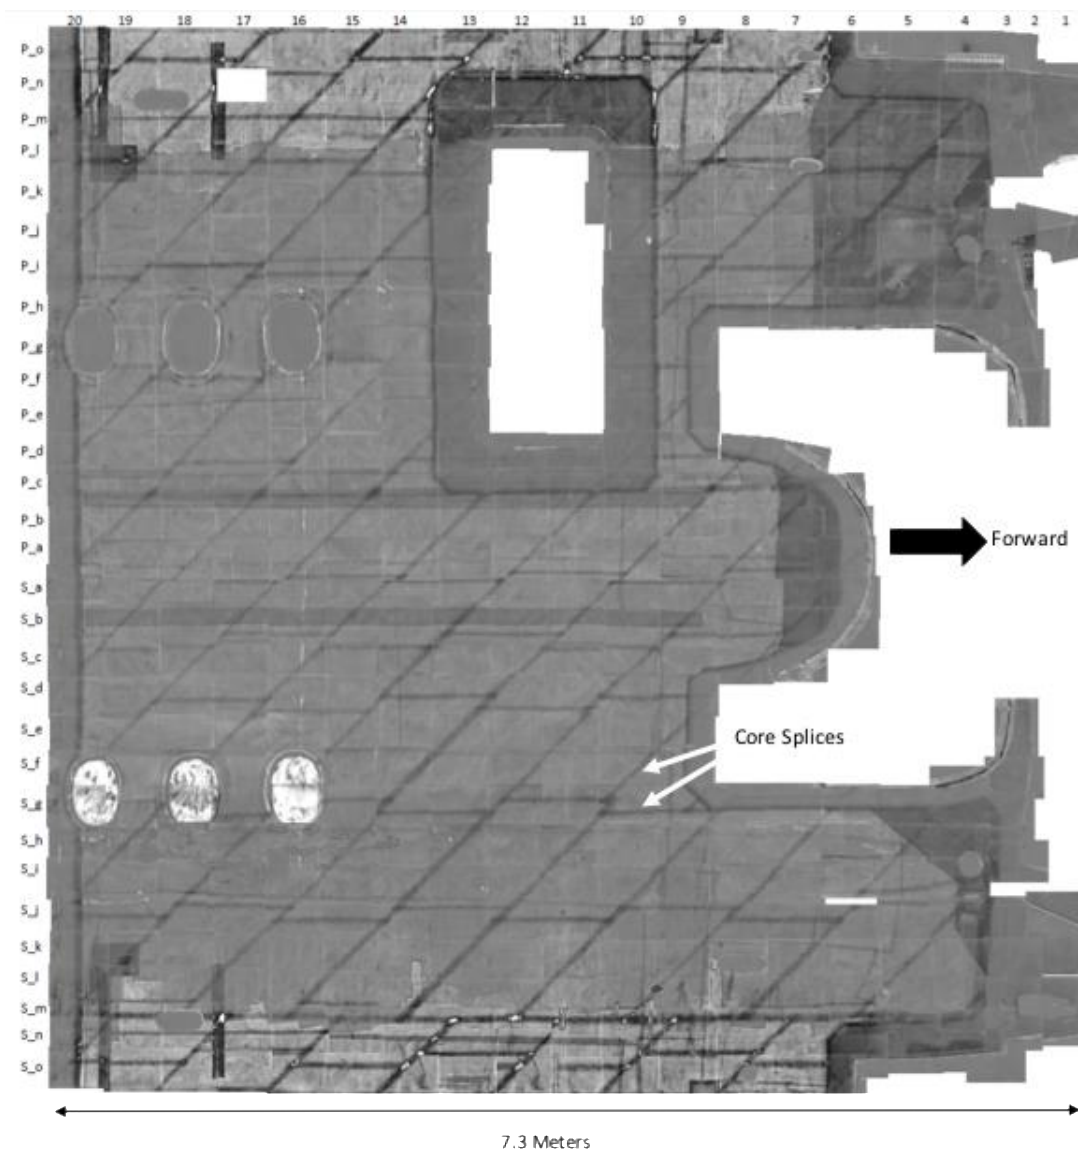
Figure 6. Entire data set assembled into one mosaic. This mosaic consists of 477 data sets processed using a fixed eigenvector.

From the averaged covariance matrix a single set of eigenvectors are calculated. The selected eigenvector, in our case eigenvector #2, is then used to process all the data sets by matrix multiplication of the fixed eigenvector with the data matrix A for a given data set. This assures the pixel grayscale values are consistent for similar material, underlying geometry, or defect. This also provides grayscale uniformity for the assembled images into one larger mosaic inspection image. This can be seen in figure 5 where the processed images from 3 data sets, starboard side Row I columns: 4, 5, and 6 are assembled. The assembled image grayscale values are not consistent from image to image for the local eigenvector calculation. These areas are marked with white circles in figure 5. The bottom row of images in figure 5 are calculated using a fixed eigenvector. These are more uniform in gray scale from image to image and helps to determine consistent underlying geometry or identify defect areas. This can be seen in figure 6 where the inspection images for the entire data set are assembled into one mosaic. This mosaic consists of 477 processed data sets using a fixed eigenvector resulting in 477 inspection images. The curved surfaces made assembling the images difficult especially as the diameter tapered toward the nose. Nonetheless, the overall 2-D image provides a good inspection of the OML fuselage forward section. The diagonal darker lines appear to be core spliced areas where core sections are attached using a foam adhesive filler with perhaps ply overlaps for reinforcement. Shown in figure 6 is the inspection area: port side, row n column 17 that was erroneously omitted during data collection. An automated robotic system would be more appropriate to ensure entire coverage.
